BULLETIN

INTERNATIONAL RAILWAY CONGRESS

A contribution to the study of rail corrugation,

By CH. FRÉMONT.

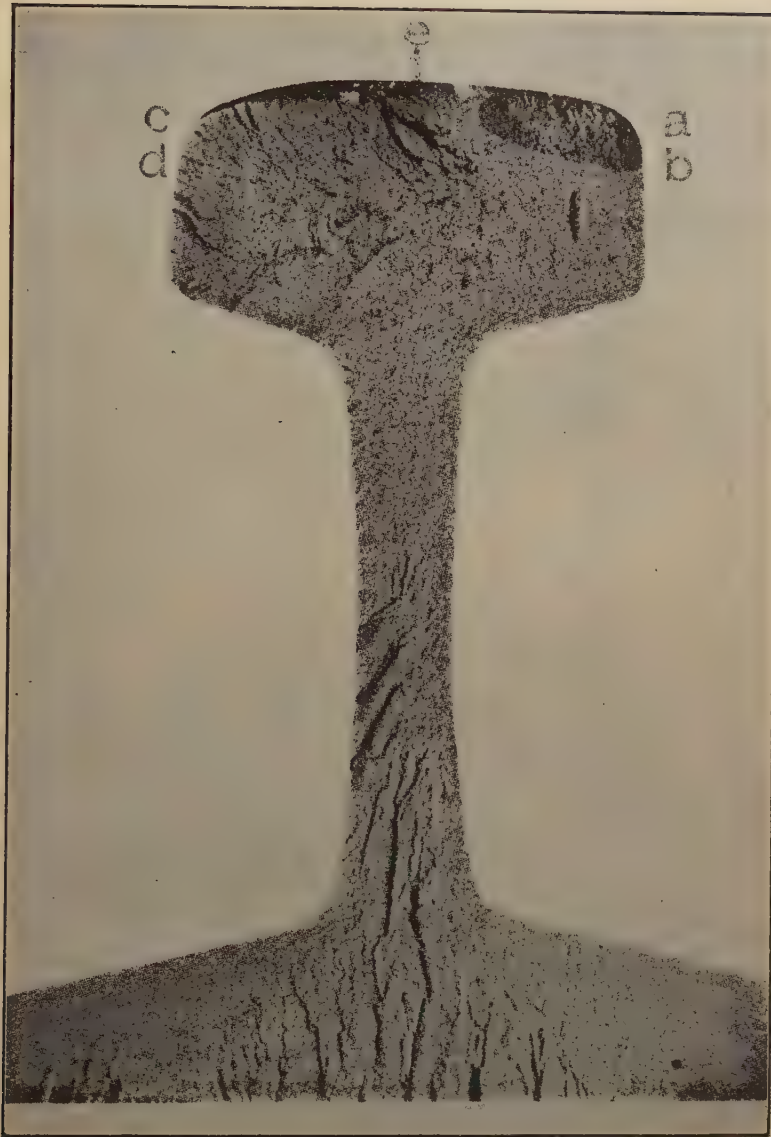
Fig. 41. — Head checked rail. Weight, 100 pounds per yard.
Microstructure shown by figures 42, 43, 44, 45, 46 and 47 for *a*, *b*, *c*, *d*, *e* and *f* respectively.

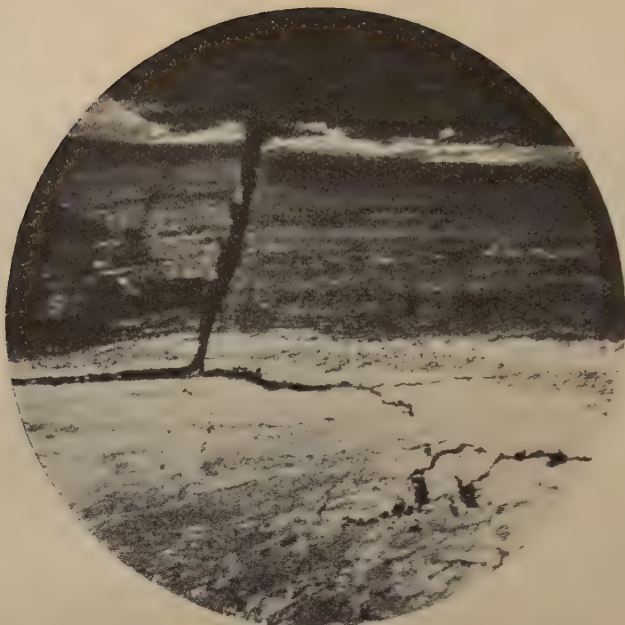
Fig. 42. — Microstructure at *a* (fig. 41).
 Hardened and cracked surface metal and hardened metal next below with outlines remaining
 of grain structure.
 Longitudinal section. Magnification 100 diameters.

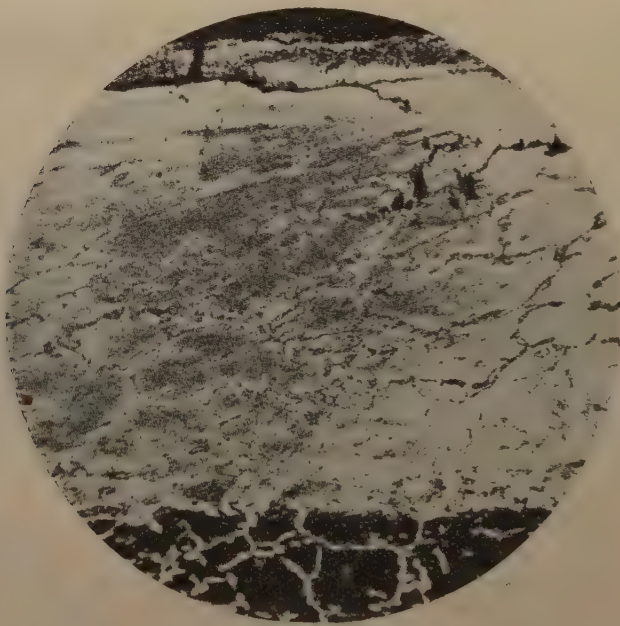
Fig. 43. — Microstructure next below *a* (fig. 42).
 Hardened zone with normal structure below. Sharp line of demarkation.
 Longitudinal section. Magnification 100 diameters.

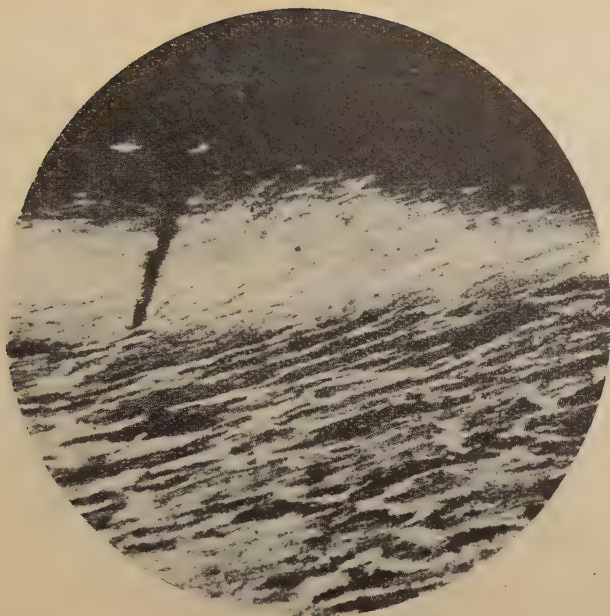
Fig. 44. — Microstructure at *c* (fig. 41), at running surface.
Hardened skin and flattening of the grains showing outward flow.
Transverse section. Magnification 100 diameters.

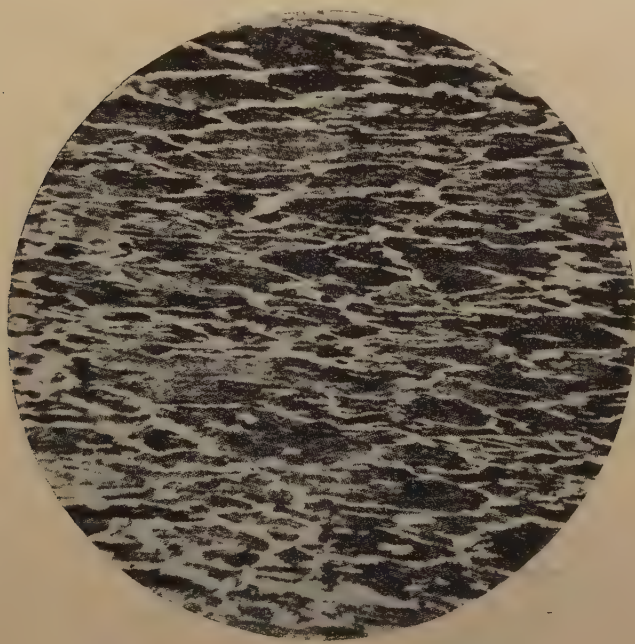
Fig. 45. — Microstructure below *b* (fig. 43),
near outside corner of the head, showing flattening of the grain, with outward flow.
Transverse section. Magnification 100 diameters.

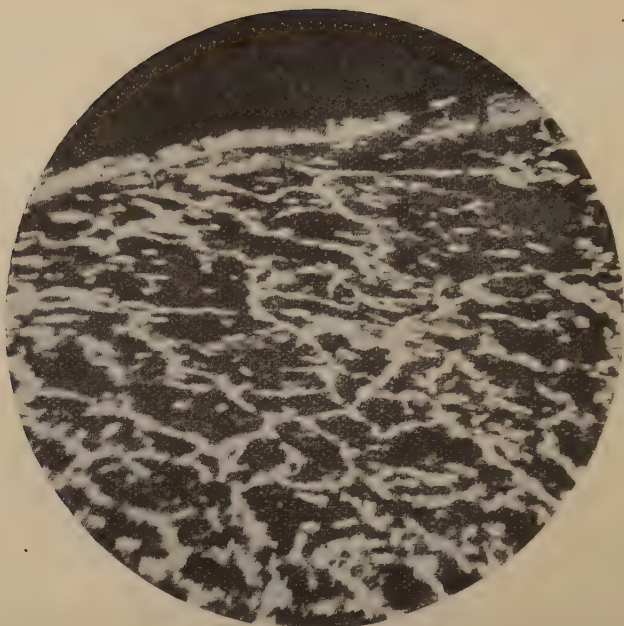
Fig. 46. — Microstructure near top of head, middle of width.
Slight hardening of the surface metal and shallow zone of flattened grain
Transverse section. Magnification 100 diameters.

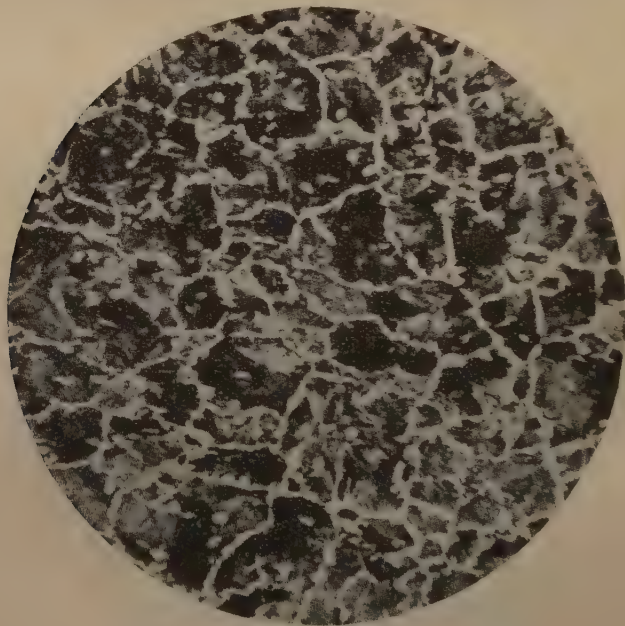
Fig. 47. — Normal structure of the steel.
Vicinity of upper part of head. Transverse section. Magnification 100 diameters.

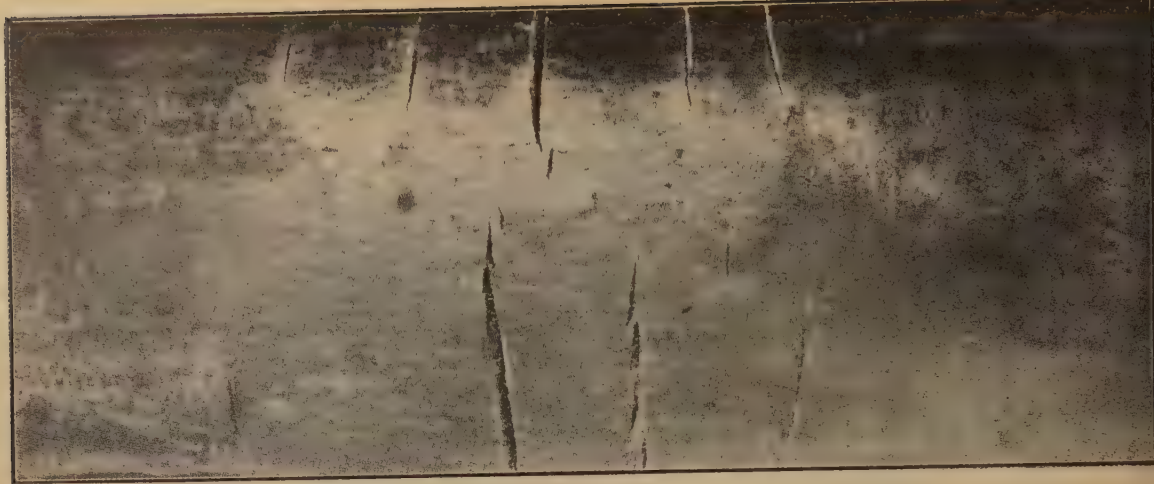
Fig. 48. — Manganese steel rail, 100 pounds weight per yard. Cracks in running surface developed in a bending test of the rail. Elastic limit approximately 54 000 pounds per square inch.

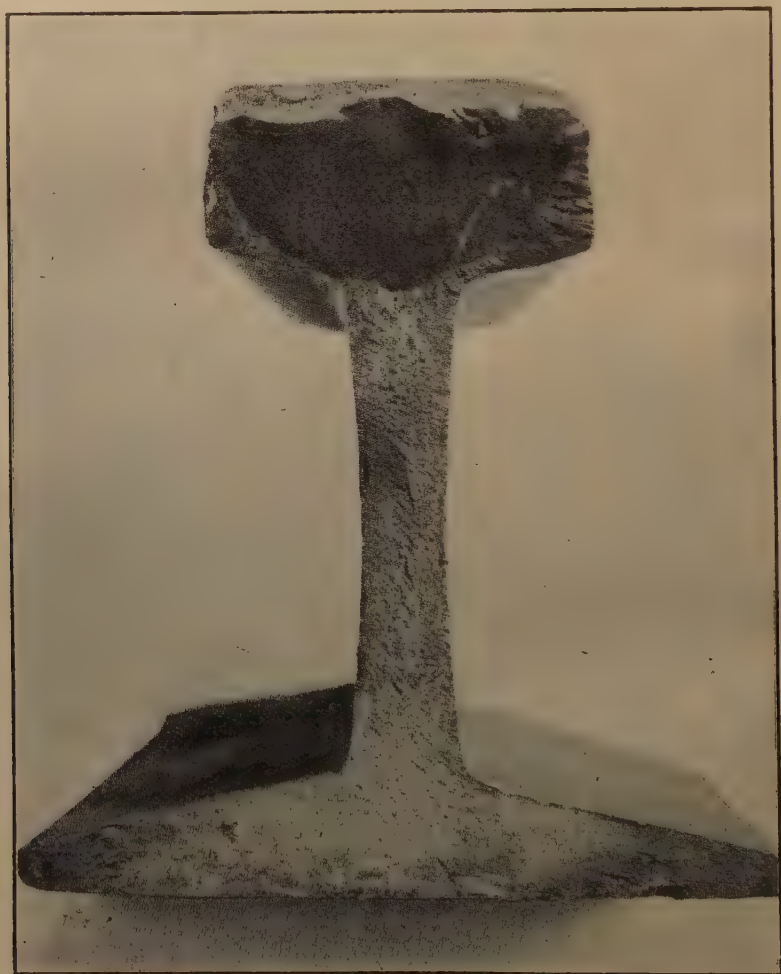
Fig. 49. — Transverse fissure displayed by a medium manganese steel rail. Bessemer steel. In service 13 years.

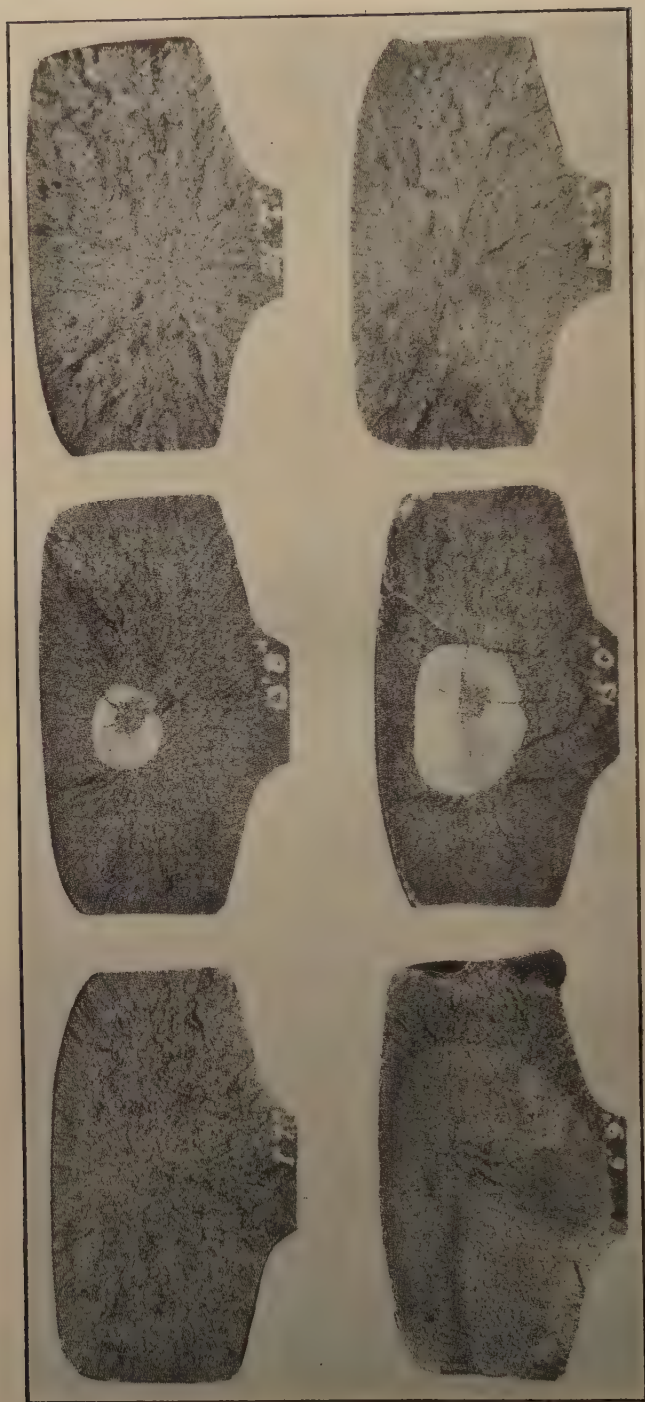
Fig. 50. — Stalling effects and transverse fissures in different stages of development in a 90-pound rail.
Fifteen fractured surfaces.

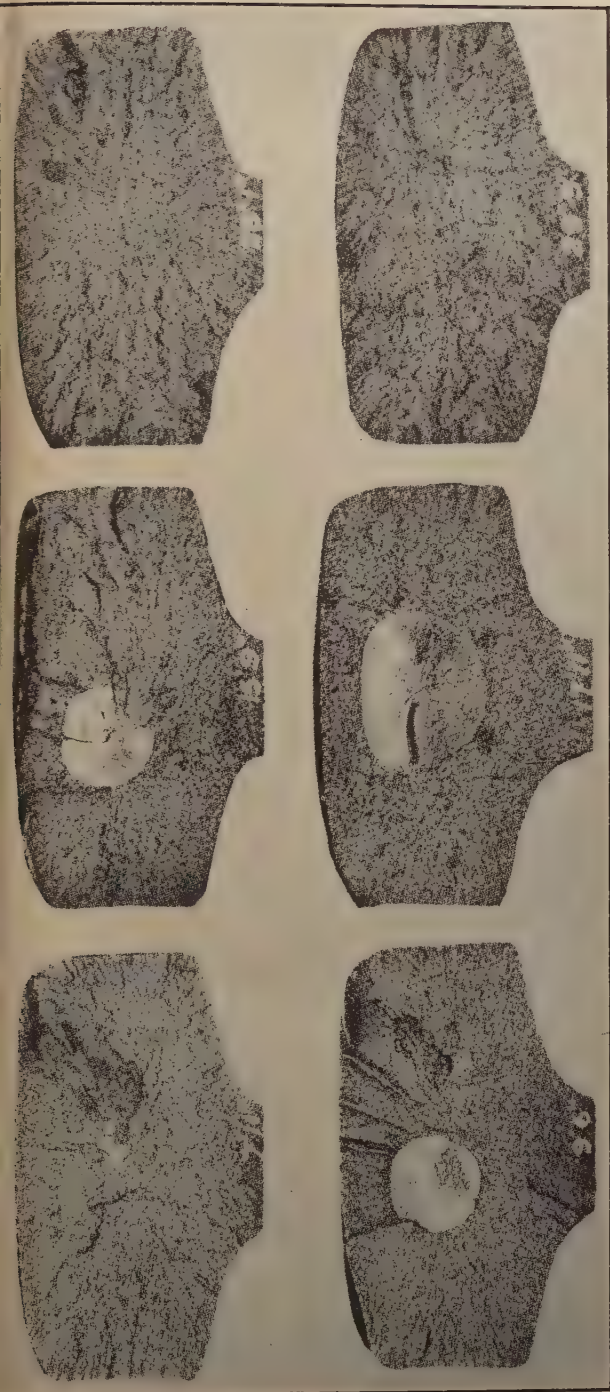
Fig. 51. — Starring effects and transverse fissures in different stages of development in a 90-pound rail. Fifteen fractured surfaces.

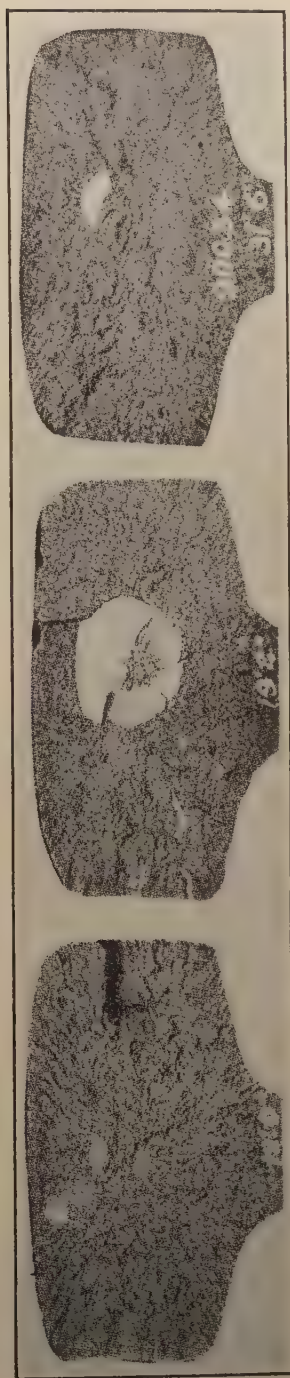
Fig. 52. — Starring effects and transverse fissures in different stages of development in a 90-pound rail. Fifteen fractured surfaces.

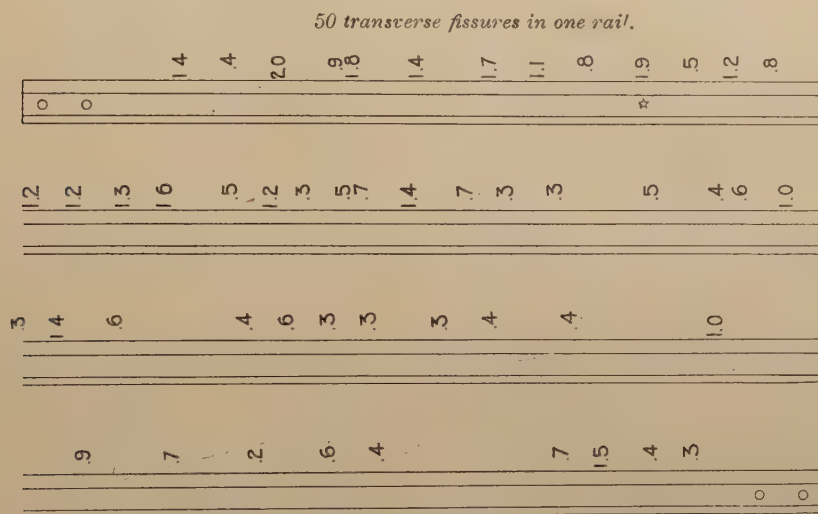
Fig. 53. — Fifty transverse fissures in the same rail.
90-pound rail about 14 years in service.

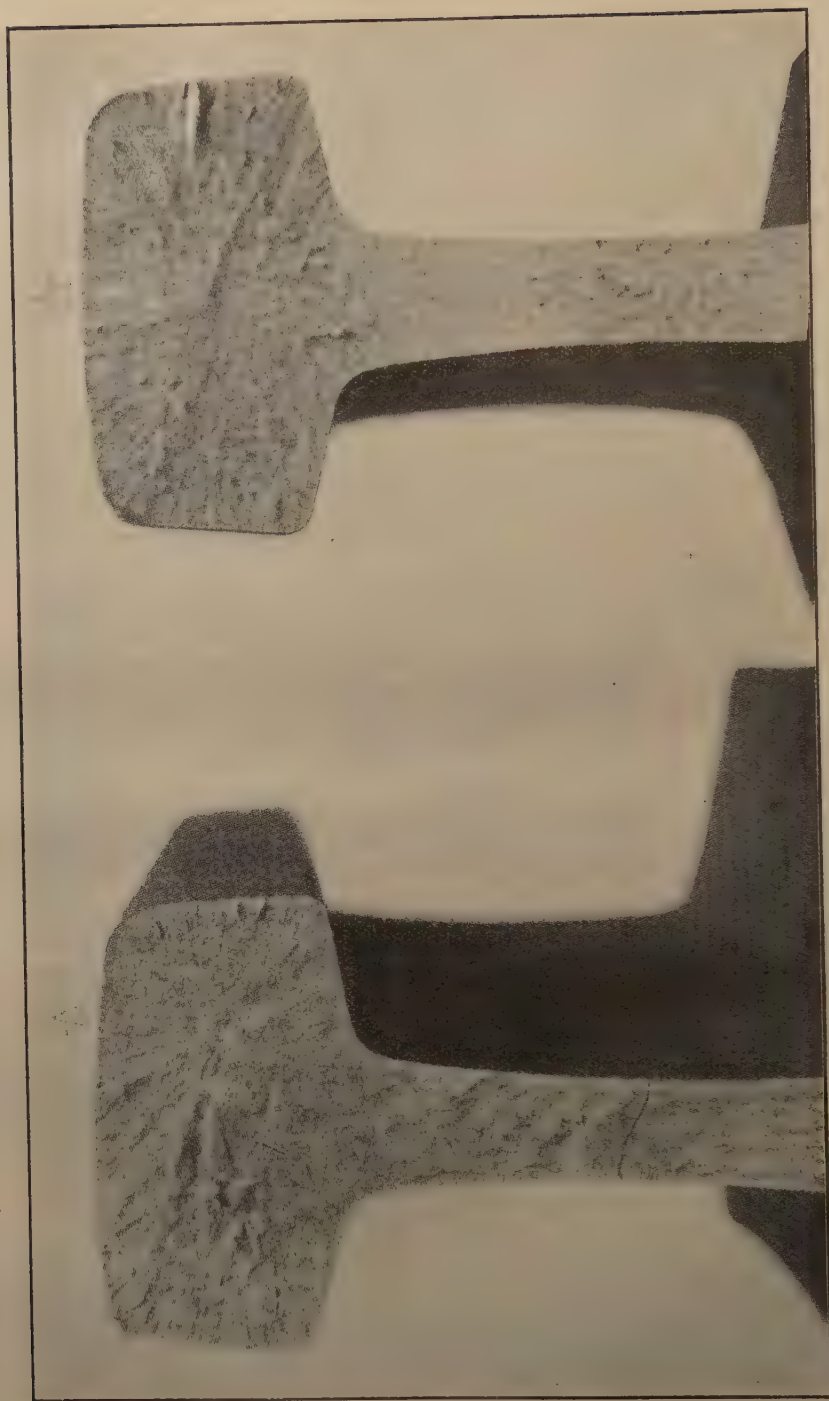
Fig. 54. — Starring effects in the heads of two rails.

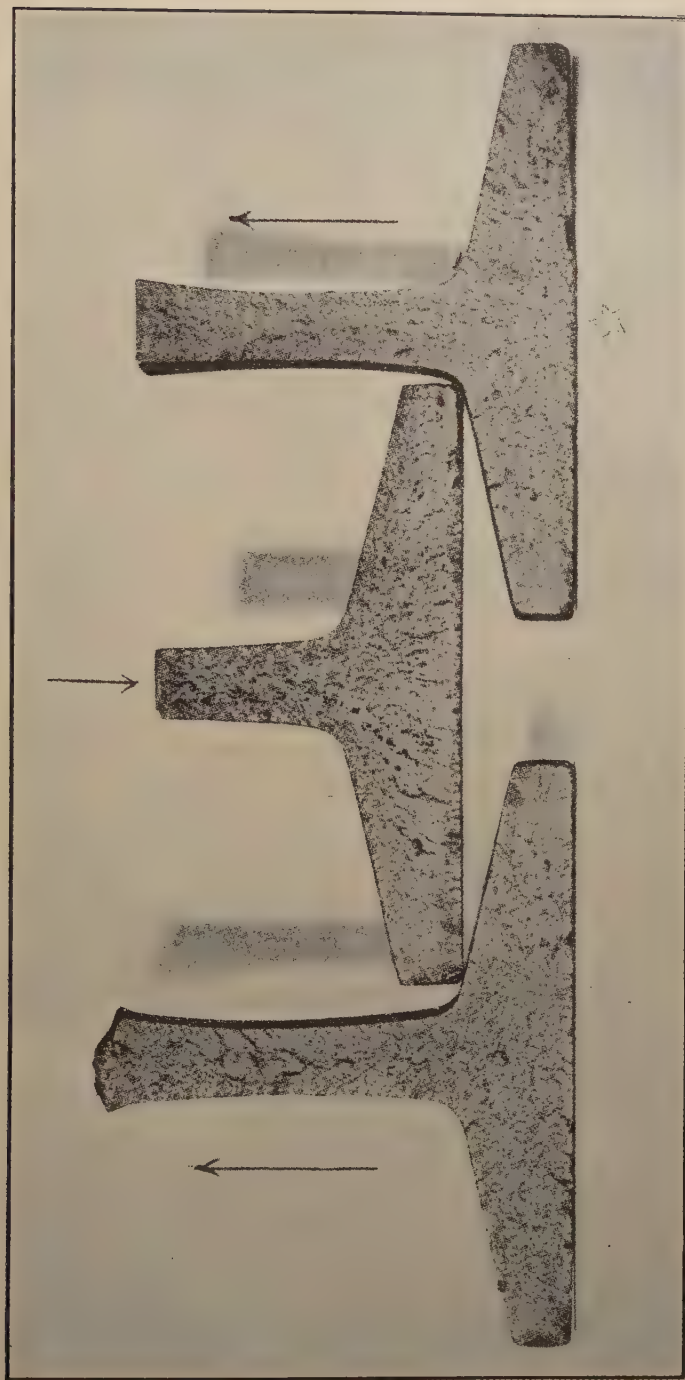
Fig. 55. — Starring effects in the bases of two rails. Fracture of third section originated under the head.
Arrows indicate the directions the lines of rupture followed.

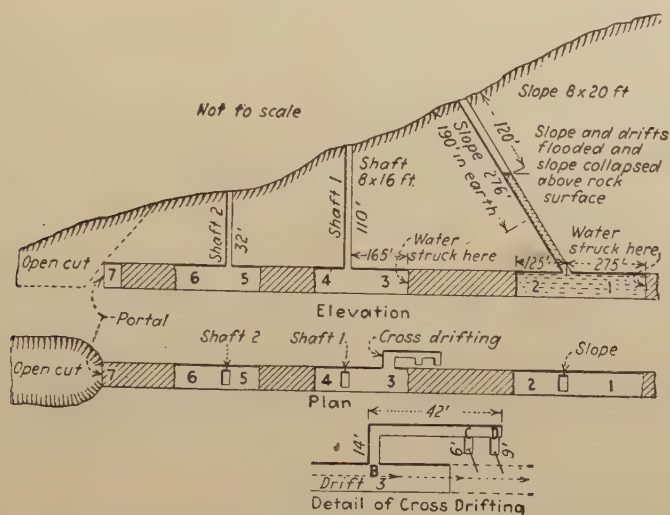
Fig. 2. — Diagram of crown drift operations in old tunnel.

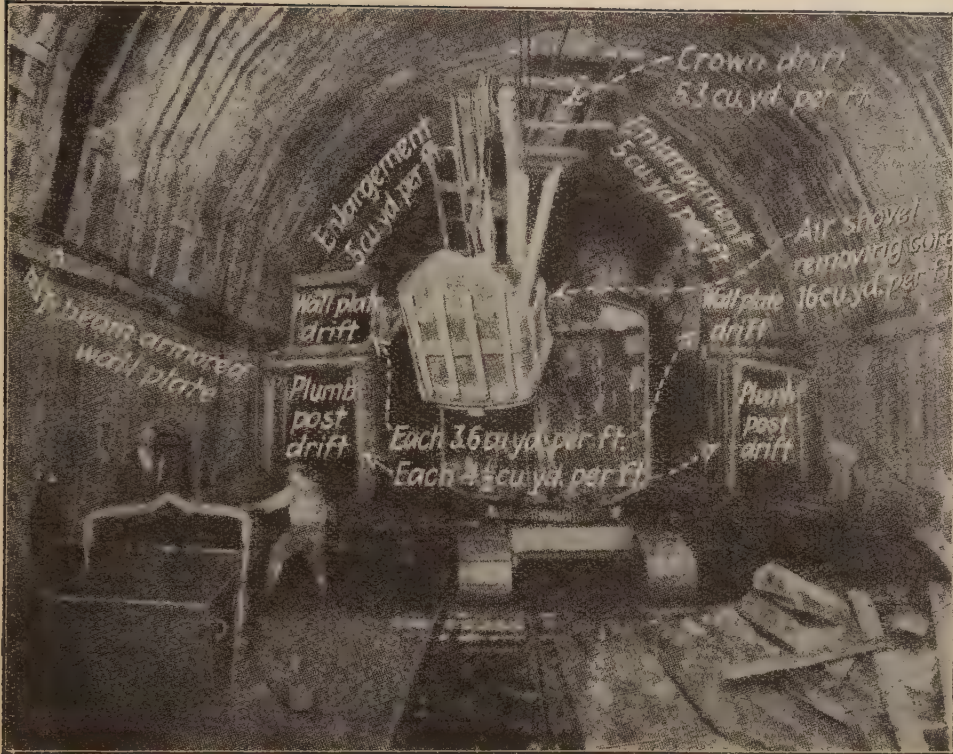
Fig. 7. — Power shovel excavating soft ground core, new tunnel.

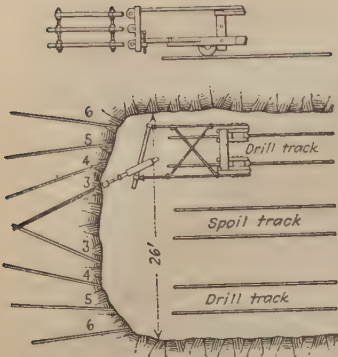
Fig. 8. — Drill carriage for heading holes in old tunnel.

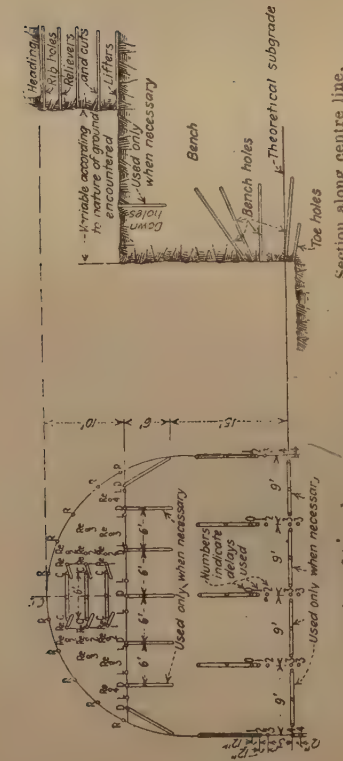
Fig. 13. — Drill hole diagram for complete round in new tunnel.

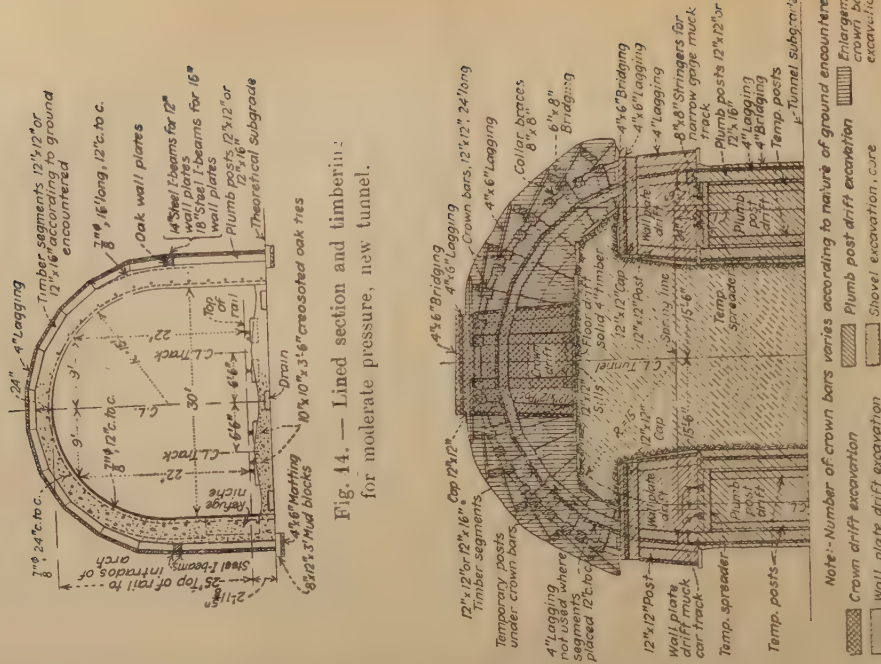
Fig. 16. — Drift and timber layout for soft ground, new tunnel.

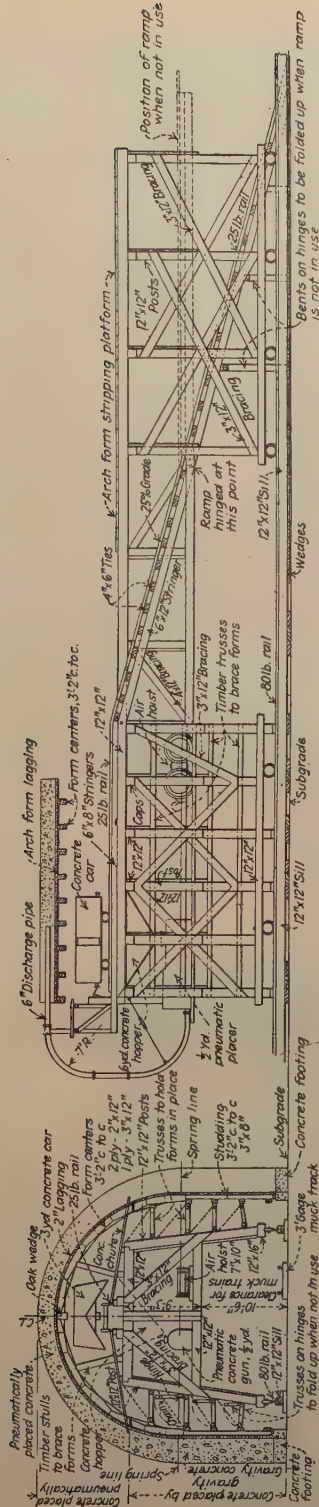
Fig. 17. — Lining traveler used on new tunnel.

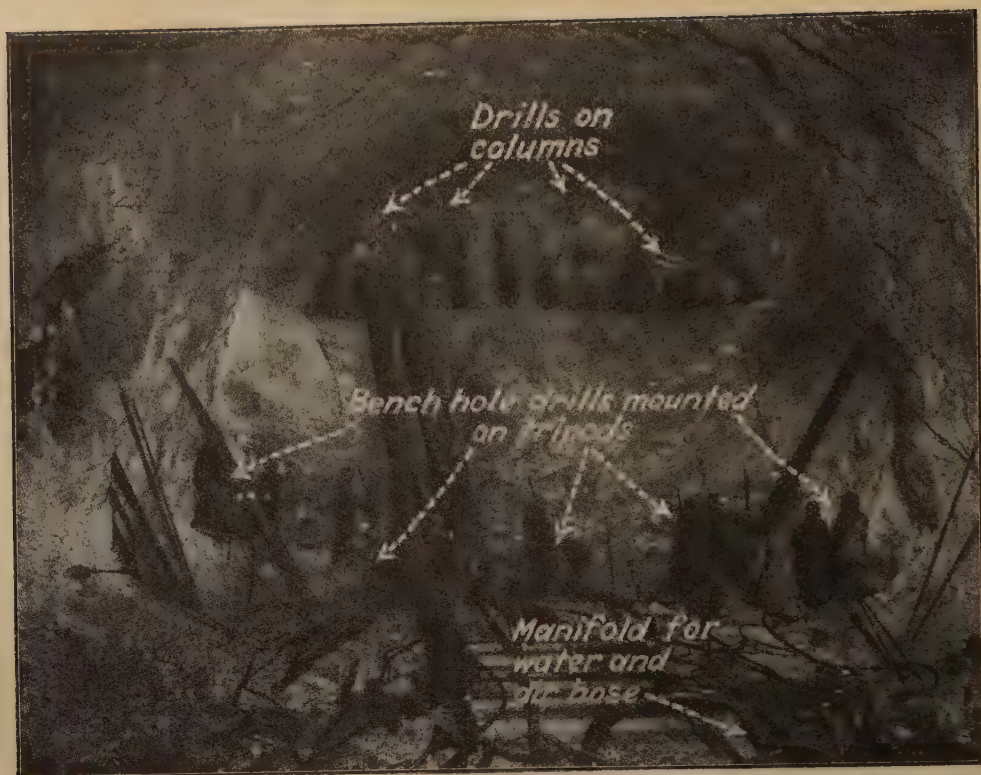
Fig. 18. — View of heading and bench in new tunnel.

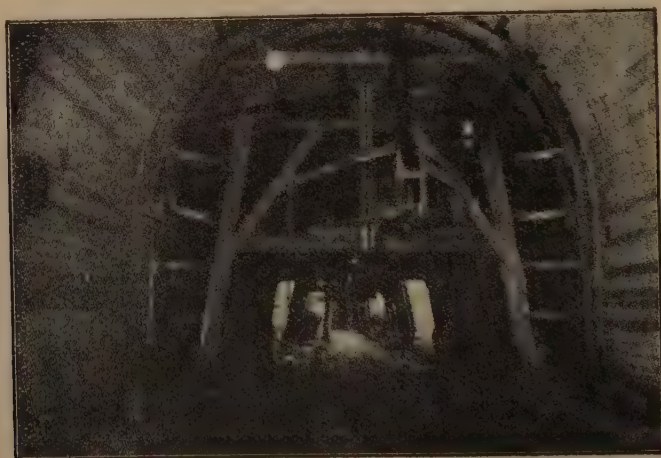
Fig. 19. — Lining traveler and forms ready for operation.

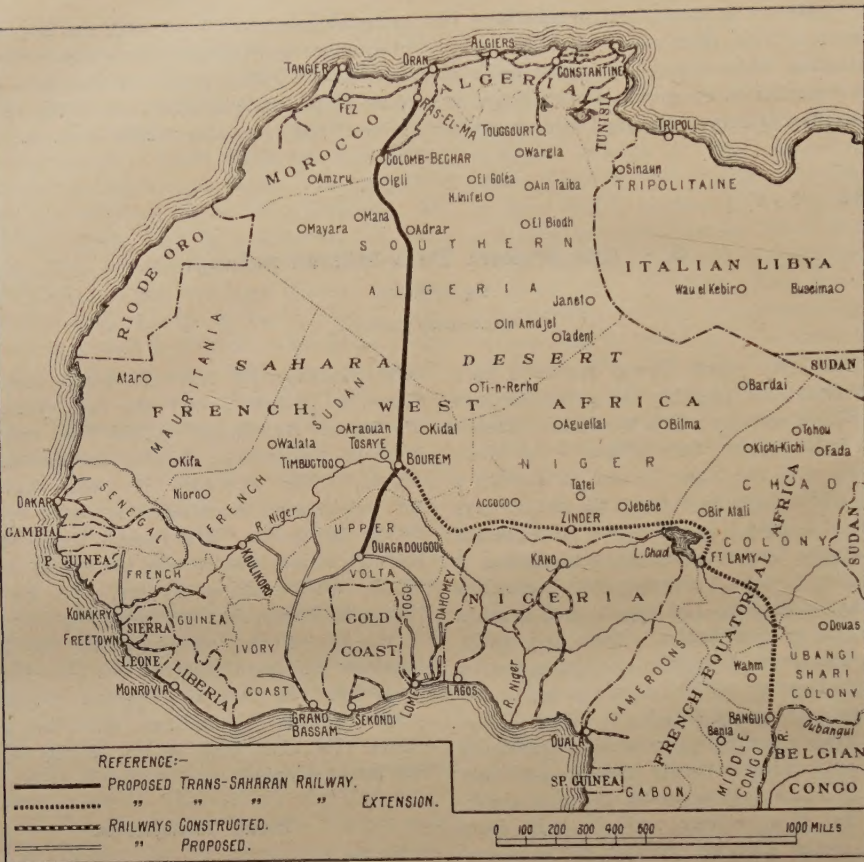
Fig. 8. — Map of North West Africa, showing route of projected Trans-Saharan railway, which would be 1 600 miles in length.
